## **ENDLESS FIBRE REINFORCED COMPOSITE- METAL-IMPELLER: HIGH SPEED BURST TESTING - DAMAGE AND FAILURE ANALYSIS**

### **SUMMARY**

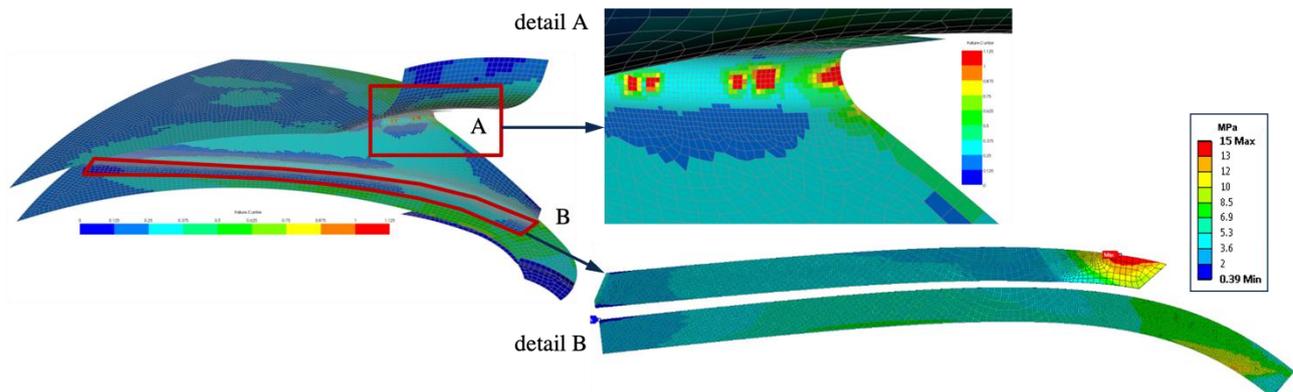
For the modular design of the impeller, two aspects are assessed: the structural effort with regards to the CUNTZE failure modes and the stress distribution in the interface in-between the blades and the disks. Figure 5 shows the CUNTZE-effort of an impeller segment (left) with the detail A of the critical area in the radius of the blade (right top) and the stress distribution in the bonding interface (left, right bottom). If damaged or failure accrue, it is expected to be at the radius of the Z-shaped blades or in the joining interface between the discs and blades.

Figure 5: CUNTZE-effort of an impeller segment (left) with the detail A of the critical area in the radius of the blade (right top) and the detail B of the stress distribution in the bonding interface (left, right bottom)

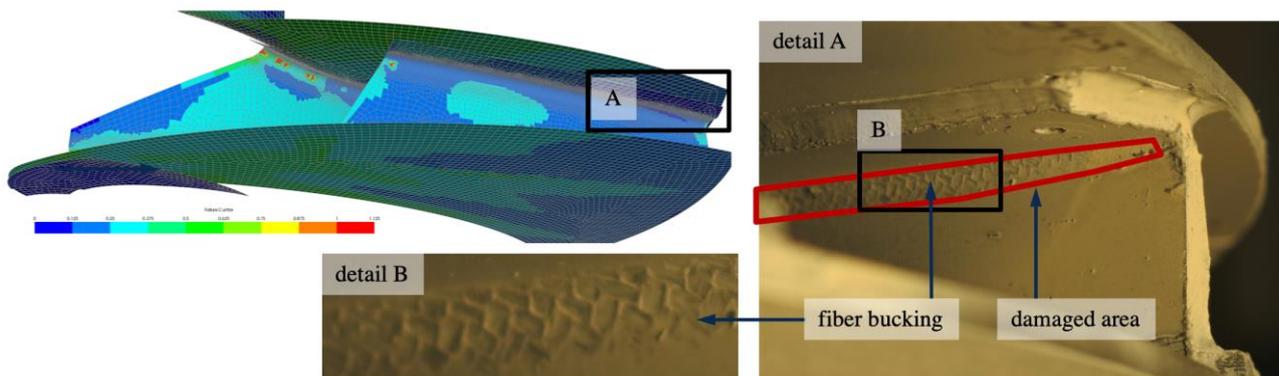
During the spin test, the impeller is inspected after defined load steps, to identify initial damage and failure of the material. Figure 7 shows the numerical model of a segment (left - top) with the area of initial damage of the impeller (detail A, right) and initial failure of the material (detail B, left). However, this initial damage does not lead to any impairment of the general functioning of the component. The initial damage occurs differently from the numerically predicted place. At the predicted point of initial failure there is no structural change or initial damage visible.

Figure 7: numerical model of a segment (left - top) with the area of initial damaged of the impeller (detail A, right) and initial failure of the material (detail B, left)

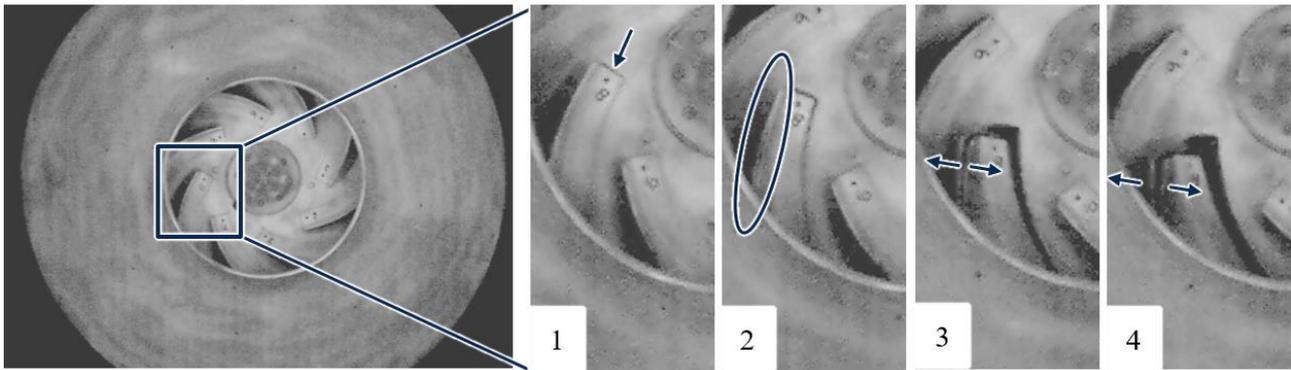
Figure 8 on the left shows the impeller during rotation. The footage shows that blade no. 08 is the first to detach from the disc. In the process, the blade itself delaminates (red line in pictures 1-4) and thus loses its load-bearing effect. After this initial failure, other blades shear off and the cover disk wobbles and fails by hitting the containment.

Figure 8: images from the high speed recordings of the impeller failure with the presumed initial failure at blade no. 08

The failure procedure is the same for all three impellers, but they reach different bursting speeds, which can be explained by the different details in the manufacturing process, e.g. copper wires or glass pearls in the bonding interface. Impellers 1-3 burst at 5,920, 6,652 and 10,266 rpm, which correspond to circumferential speeds of 310, 349 and 538 m/s for a diameter of 1050 mm.

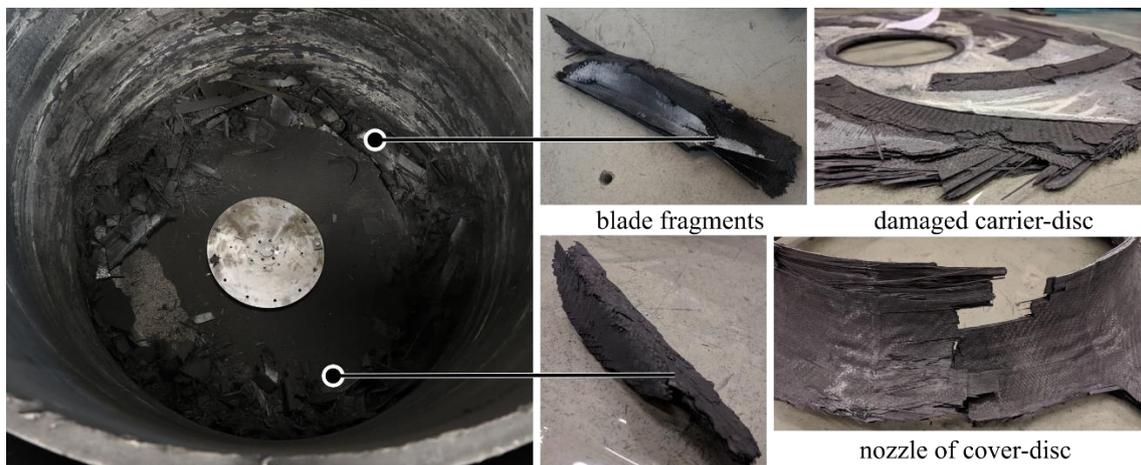
The modular impellers fail mainly in the joining areas, resulting in fragments in the form of the individual components or characteristic elements (acc. Figure 9).

Next to the individual blades, the discs can be clearly seen, with the flat carrier disc as a disc. The cover disc has disintegrated into smaller fragments. The nozzle is recognizable as a closed ring. All individual parts show strong delamination, especially near the impact areas.

Figure 9: burst impeller (left) and fragments of the bursted impeller (right)

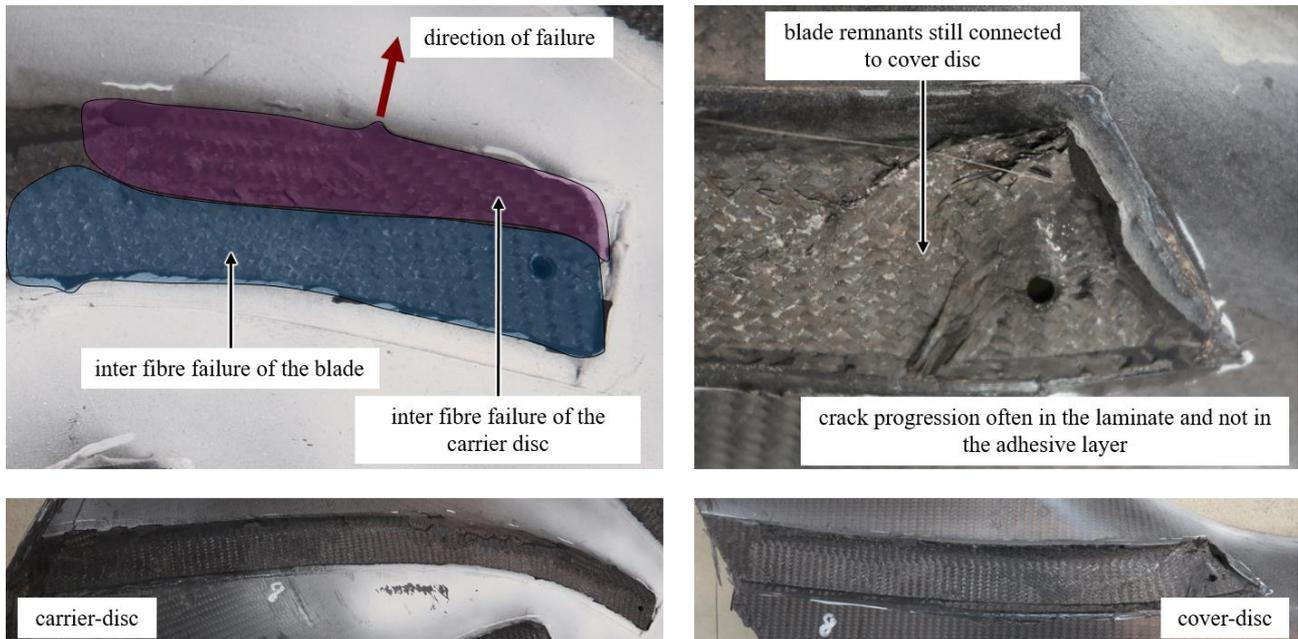
Remarkable are the fracture surfaces between the blades and discs (acc. Figure 9, right top). It can be seen from the fragments that interlaminar failure has occurred in the joint area between the blade and the discs, with the fracture shape alternating between failure in the laminate of the blade and failure in the adhesive layer (acc. Figure 10, left top). Minimally noticeable fragments of the discs can also be found on the vanes (acc. Figure 10, right top). This fracture pattern is characteristic of a mixed fracture and indicates that the interlaminar strengths of the fibre composite and the strength

of the adhesive are at similar levels, which under the given test conditions (dry and ambient temperature) can be interpreted as a suitable choice of material.

Figure 10: fracture surfaces of the fragments with interlaminar failure in the components of the blade, the disks and the adhesive

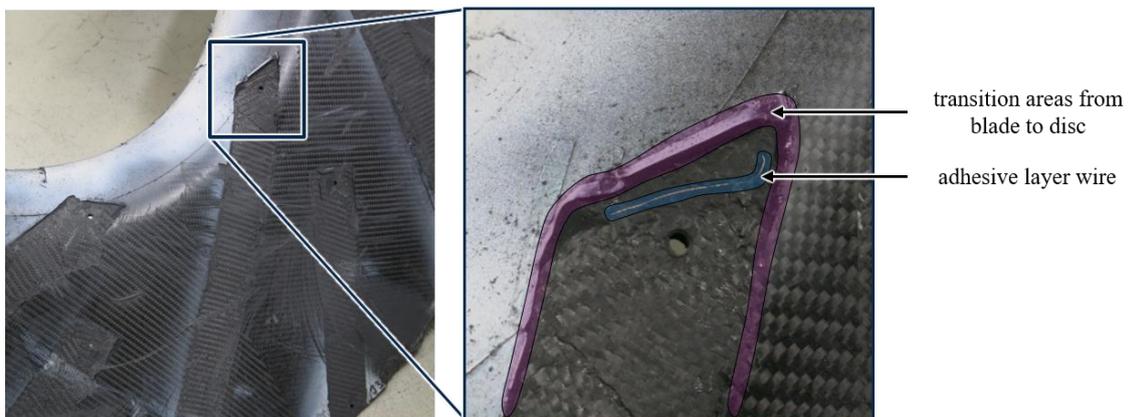
In the fragments of impeller 1, the cause of the initial failure can be deduced (acc. Figure 11, left). The copper wire inserted to adjust the slit is located in the fracture surface. The wire in combination with the still relatively undefined geometry of the transition areas from blade to disc and the comparatively low manufacturing quality may be the cause of the lowest circumferential speed of 310 m/s (acc. Figure 11, right).

Figure 11: fragments of impeller 1 with the potential crack initiator in the form of the inserted adhesive layer wire

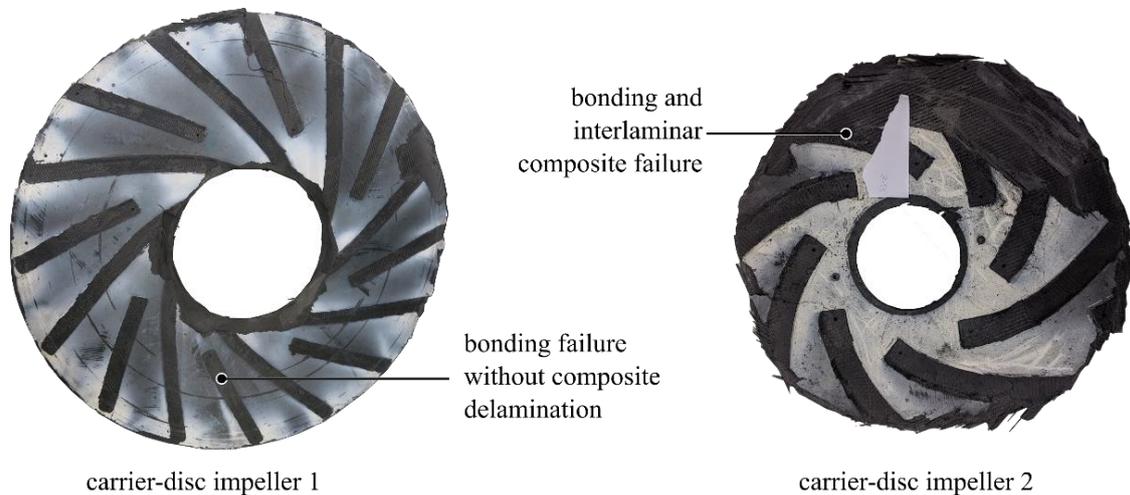
Due to the relatively low circumferential speed (310 m/s) of impeller 1 (acc. Figure 12, left) at the time of failure and the almost exclusive failure of the bonding interfaces, the carrier disc remains largely intact. The carrier disc of the impeller 2 (acc. Figure 12, right), on the other hand, is more severely damaged due to greater centrifugal forces caused by an increased circumferential speed (538 m/s) at the time of failure. In addition, fibre composite delaminations contribute to damage of the structure due to the increased joint strength.

Figure 12: fragment of the carrier-disc of impeller 1 (left) and impeller 2 (right)
