Autonomous and Air-Ground Cooperative Onboard Systems for Surface Movement Incident Prevention

Dissertation

Dipl.-Phys. Christoph Vernaleken

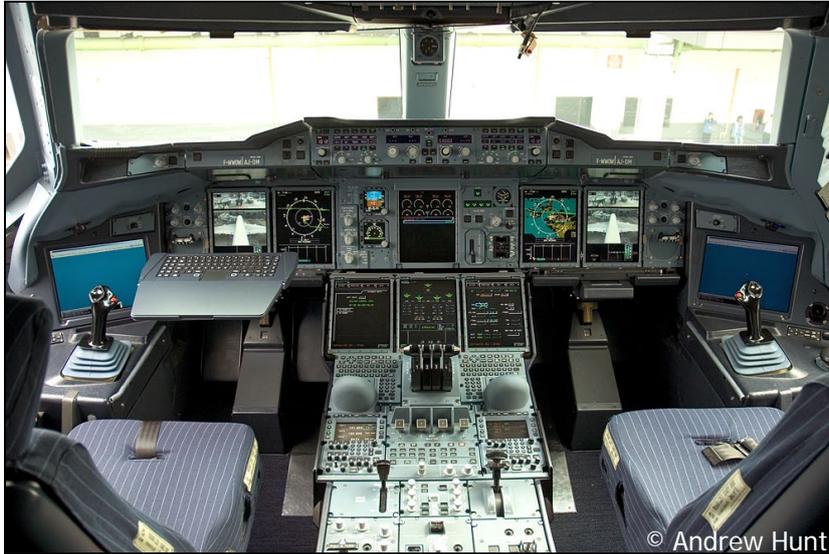
Figure 13: A380 Cockpit Overview

The classic ND, range and mode are controlled via the corresponding selectors on the EFIS control panel in the glareshield. The airport moving map can be viewed in five fixed ranges of 5, 2, 1, 0.5 and 0.25 NM. Additionally, using the Keyboard and Cursor Control Unit (KCCU), pilots can call up a dedicated tab menu with additional soft controls in the display area immediately below the airport moving map, as shown in Figure 14. Among others, this menu enables pilots to select a different airport for display by entering ICAO code, IATA code or city name.

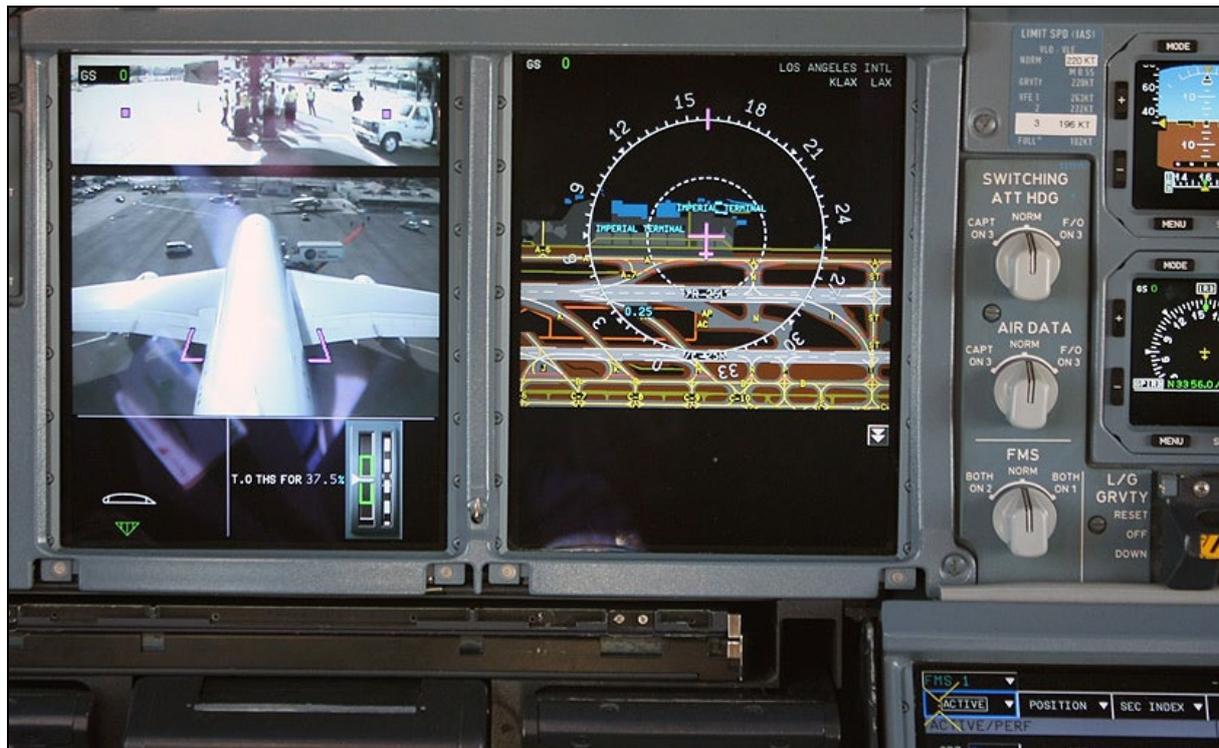
Figure 14: Airbus A380 Onboard Airport Navigation System (OANS)

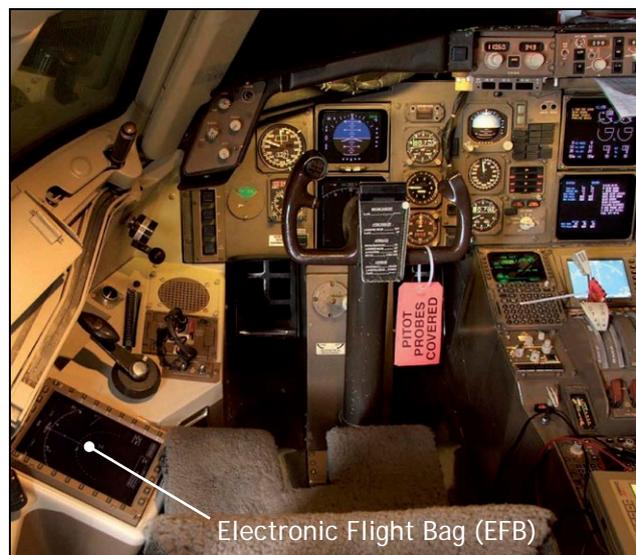
Figure 18: EFB with SafeRoute in a UPS B-757

Currently, the main SafeRoute customer is United Parcel Service (UPS), who was also strongly involved during the development phase. UPS is planning to install the system on its entire Boeing B-757 and B-767 fleets by the end of 2009. Figure 18 illustrates the location of the EFB with the SafeRoute application in the cockpit of a UPS Boeing 757 [Ger07]. Additionally, UPS intends to use the application to decrease taxi delays or inefficient routing to and from the parking positions at its Louisville (KSDL) hub [Flt07].

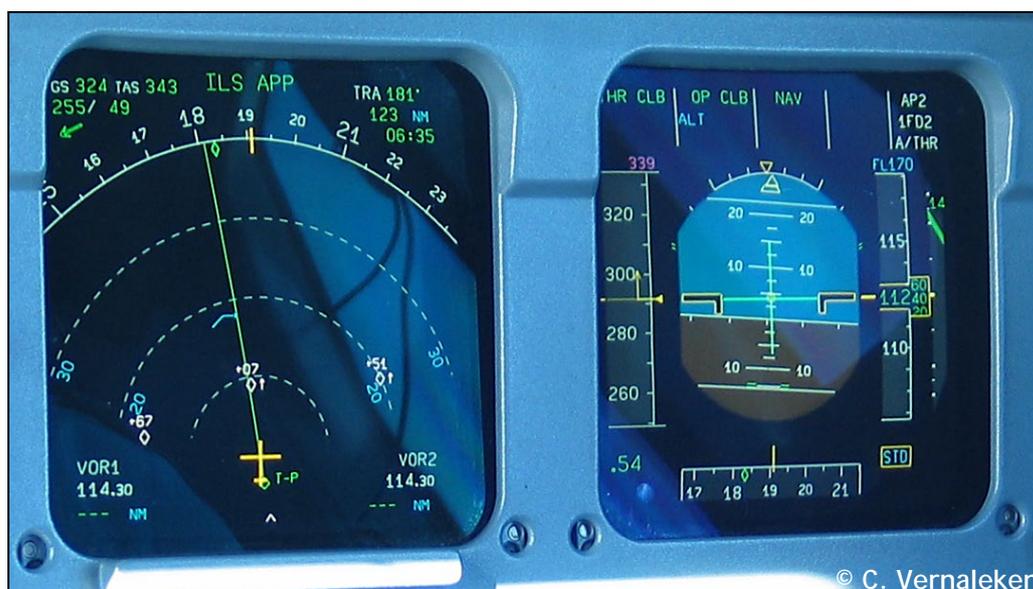
Figure 21: Airbus A320 family EFIS with TCAS traffic presented on ND

Traffic is displayed in relation to a symbol reflecting ownship position⁴⁴, on a display featuring range rings, see Figure 21. The representation of other traffic is typically limited to a vertical volume of ± 2700 ft, and the symbology used depends on alert state and proximity of the corresponding traffic, as shown in Figure 20.

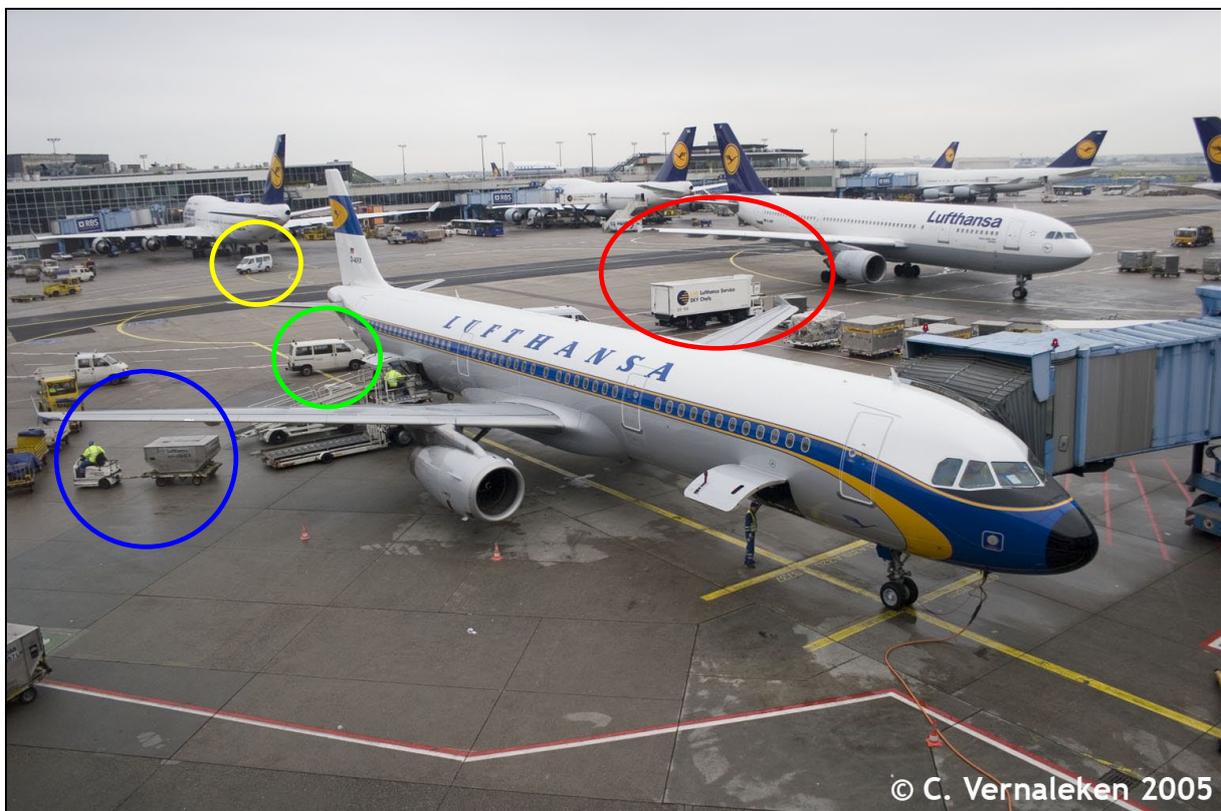
Figure 28: Apron scenario at Frankfurt Airport (EDDF), Spring 2005

All of these issues can be nicely demonstrated using the photo of an apron scene at Frankfurt Airport (EDDF) depicted in Figure 28: Several vehicle roads are designed such that they run beneath the tails of parked aircraft, as can be seen from the vehicle in the yellow circle. The tail of the parked Boeing 747-400 thus protrudes into the ve-

Since airport vehicles account for a significant share of airport surface traffic, cf. Figure 28, the display policy for vehicles appears to be a key element of controlling display clutter.

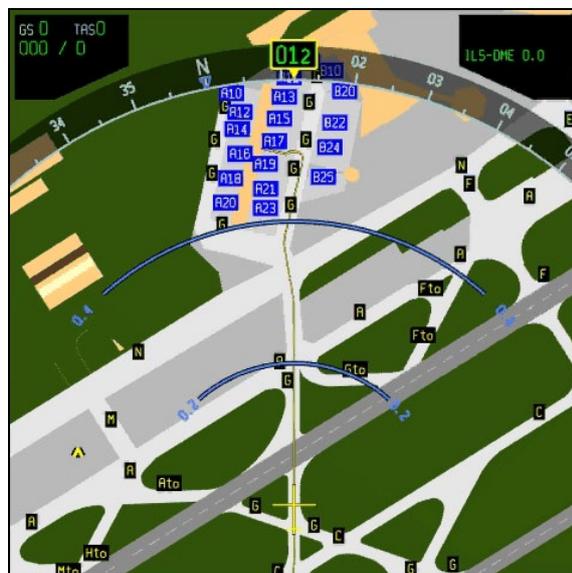
Figure 30: The Institute's AMM prototype at the beginning of SMAAS development

The existing airport moving map prototype available at the Institute of Flight Systems and Automatic Control (see Figure 30) was used as a starting point for the development in this thesis. It had been conceived as a demonstrator based on the pioneering work of the Institute in the field, cf. [Kub99]. From a Runway Incursion avoidance perspective, however, the crucial drawback of this design is the absence of taxiway holding positions and stop bars. Furthermore, there is a lack of contrast between apron areas and the runways. Its main technical limitation was that AMDBs could only be visualised after offline processing into a single Open Inventor file with pre-defined content and colours, which resulted in two major disadvantages. The first was that any runtime changes of airport moving map design and features in

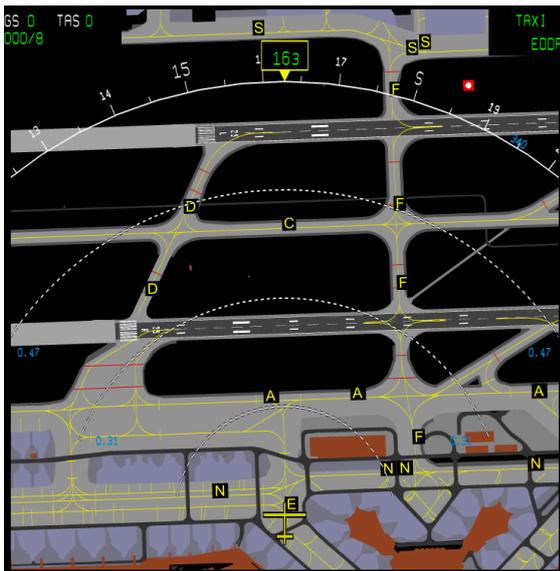
Figure 31: Initial airport moving map design before prototyping

Taking into account the general Human Factors engineering guidelines for electronic cockpit displays laid down in standards such as SAE Aerospace Recommended Practices ARP5364 [SAE03] and based on the analytical considerations in the following sections, an initial refined airport moving map design (Figure 31) was then drafted and subsequently refined in several prototyping sessions with test and technical pilots. Prototyping was aimed at a fine-tuning of the human-machine interface prior to the simulator assessment with airline pilots described in Chapter 8. The underlying objective of this iterative validation approach and subsequent refinements was to enable an assessment focussing on

Figure 36 shows the preliminary colour concept proposed for the AMM, using various shades of slightly bluish grey to reflect the difference between runways, taxiways and apron areas. Furthermore, an initially envisaged distinction of parking stand areas and apron areas (shown only in Figure 31) had been found to increase display clutter in a first design review with project test pilots, and thus been discarded.

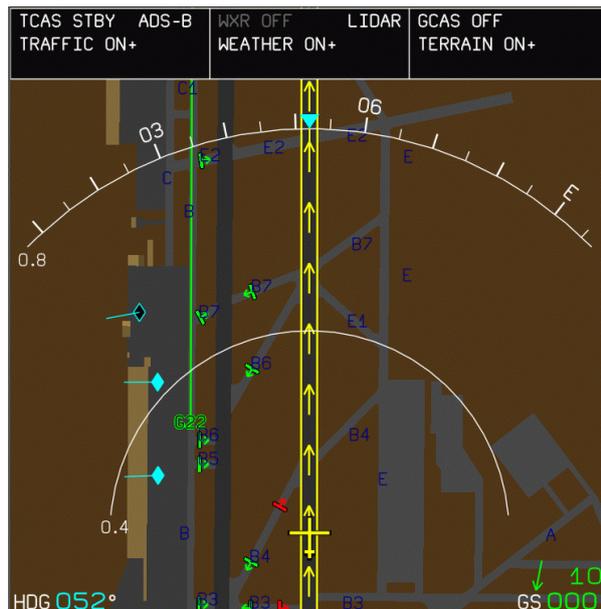
Figure 46: Active runway representation in ISAWARE [RM01]

Figure 46 shows the active runway representation chosen for the European research project ISAWARE. On the display, the runway centreline marking is replaced by equidistant yellow arrows, and the runway outline is highlighted in yellow as well [RM01]. However, an issue with this representation is that this type of marking has, according to ICAO Annex 14, already an entirely different and contrary meaning: white arrows instead of the normal centreline markings are used to indicate a displaced runway threshold [ICA04b]. Despite the fact that the ISAWARE symbology uses yellow instead of white, it might give pilots the hazardously misleading impression that the threshold is displaced and still ahead of them. This risk is particularly high if the symbology is applied without any other runway markings, as shown in the figure, or when only part of the runway is visible on the airport moving map during landing. Apart from this, when superposed over the normal runway markings, the ISAWARE symbology will most likely lead to display clutter. Last but not least, the exclusive use of yellow, a colour associated with taxiway markings, has to be criticised.

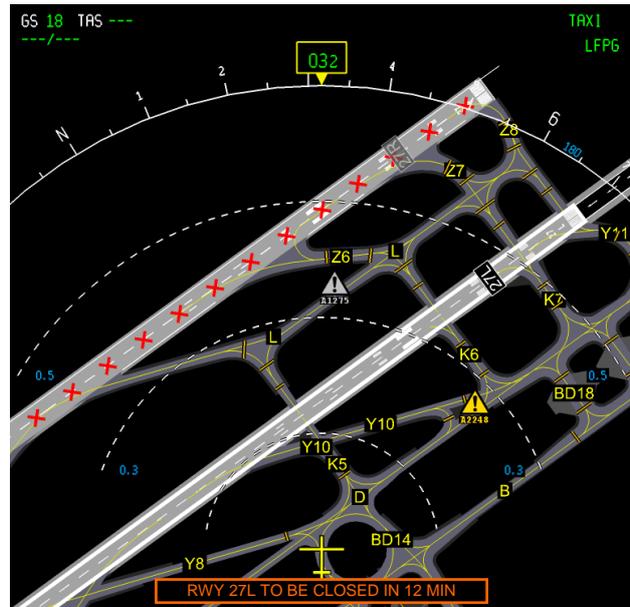
Figure 55: Active and expired attention-getting symbol for non-decodable NOTAM

For short-term and temporary restrictions conveyed via the generic attention-getting symbol, the proposed symbol accompanied by the NOTAM number could be changed from a yellow-coloured active representation to a grey expired representation, as shown in Figure 55.

- ❖ **RWY 27L TO BE CLOSED IN 18' 25''** will be visualised as a text countdown on the ND if the FMS-selected take-off runway (RWY 27L in this example) is, based on NOTAM information, expected to be closed within 30 min. As shown in Figure 55, the font colour changes from white to amber if time remaining before closure decreases below 15 min. For a landing runway, the ETA at the airport must be within 45 min for this message to be displayed, which ensures that runway closures beginning during the flight, but ending well before the aircraft's arrival are filtered and do not distract the flight crew.

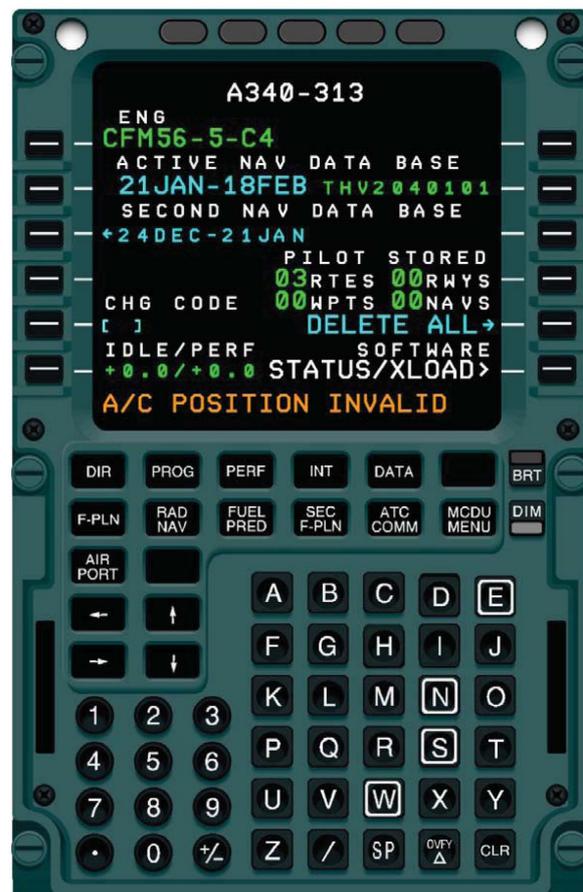
Figure 59: Multipurpose Control Display Unit (MCDU) currently used on Airbus A330/A340 [Tha05]

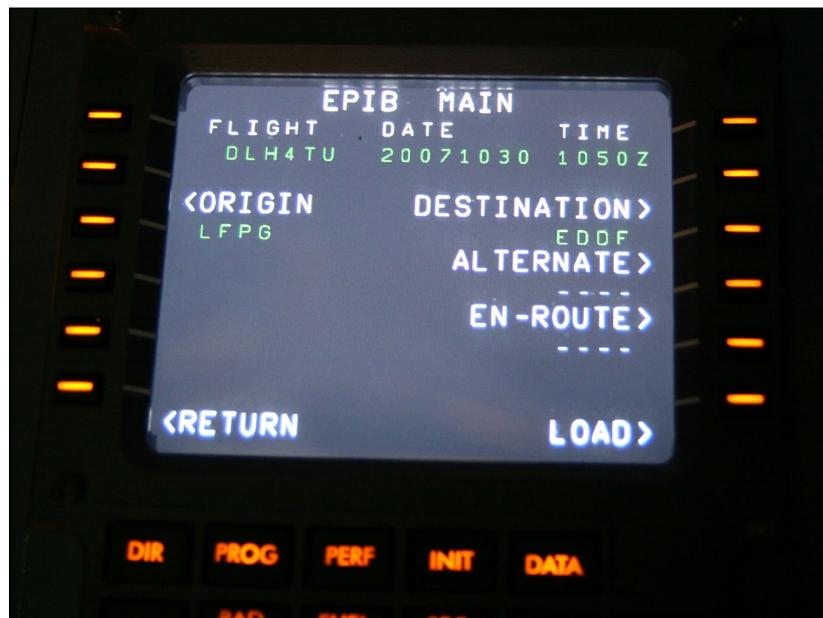
Figure 60: ePIB Main Page displayed on the MCDU in the TUD simulator cockpit

The proposed ePIB Main menu (see Figure 60) contains fundamental PIB information, such as applicable flight number, creation date and -time. Below, a typical MCDU menu enables a structured review of ePIB information based on the grouping of NOTAM information in a conventional PIB [DLH06a]. It is envisaged that flight crews can use this menu structure to obtain an overview of the NOTAM available for origin and

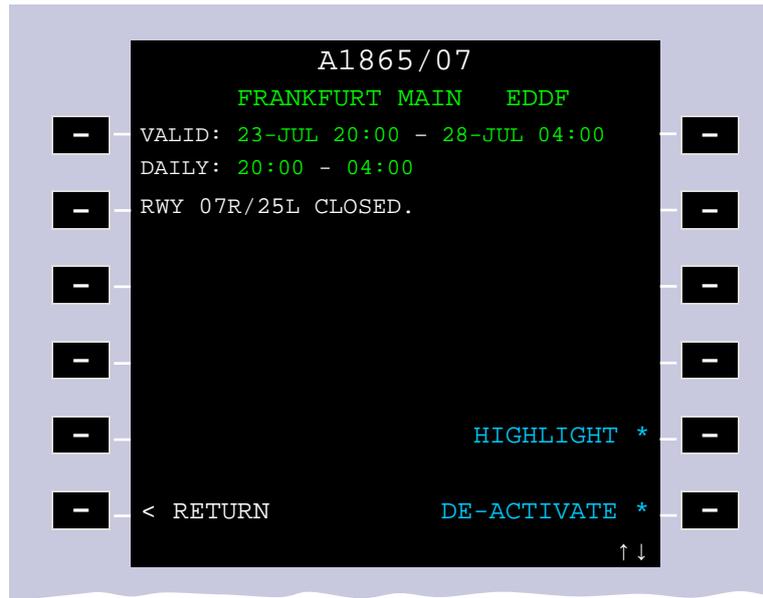
Figure 61: ePIB NOTAM review page with highlight & de-activation function

departure airport, en-route segments or alternate airports and eventually access individual NOTAM, as shown in Figure 61. This would also give pilots the possibility to manually de-activate NOTAM that have been cancelled or to highlight the aerodrome elements concerned by a certain NOTAM on the airport moving map. A more detailed description of the ePIB MCDU pages and the underlying design considerations can be found in Appendix III-1.

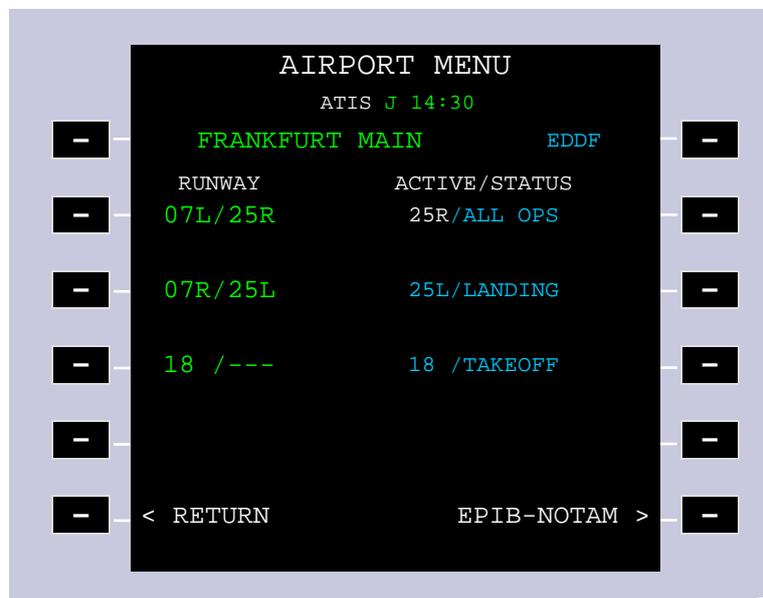
Figure 62: SMAAS Main Page (MCDU)

Figure 62 illustrates the solution evaluated in the frame of this thesis. The Airport Menu presents both official name and ICAO identifier of the currently selected airport. Besides, an ATIS code letter and the associated release time are indicated to emphasise on which ATIS transmission the information presented is based. In contract mode, the system would automatically receive the latest D-ATIS information on the runways in use and closed runways, if applicable.

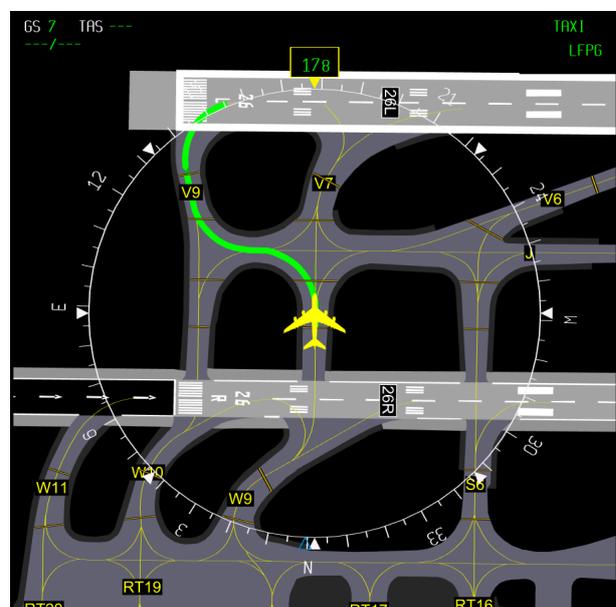
Figure 69: Taxi route with additional approval to line up and wait on RWY 26L

Apart from defining additional symbology, the only remaining options are a visualisation of the line-up approval by a taxi route extending onto the runway surface, or via the colour of the associated taxiway holding positions/stop bars. Both options can obviously be combined, and this is the solution chosen for this thesis, as shown in Figure 69. A line leading towards the runway centreline is displayed as part of the taxi route, using the existing extension of taxiway centrelines onto the runway as required per ICAO Annex 14 [ICA04b]. Additionally, once an approval to line up on a runway has been acknowledged by the crew via CPDLC, the colour of the taxiway holding position changes from red back to the default representation. Simultaneously, the lead-on route changes from cyan to green. Conditional line-up approvals are visualised in exactly the same fashion as taxi instructions, with the addition that the colour of the holding position only changes when the condition has been fulfilled. All of these solutions for visualizing approval to cross, backtrack or line up on a runway are deliberately very different from the representation of the take-off clearance, which is intended to ensure that there is no confusion. After all, in RT phraseology, the word 'clearance' is intentionally avoided for all cases except take-off and landing for the very same reasons.

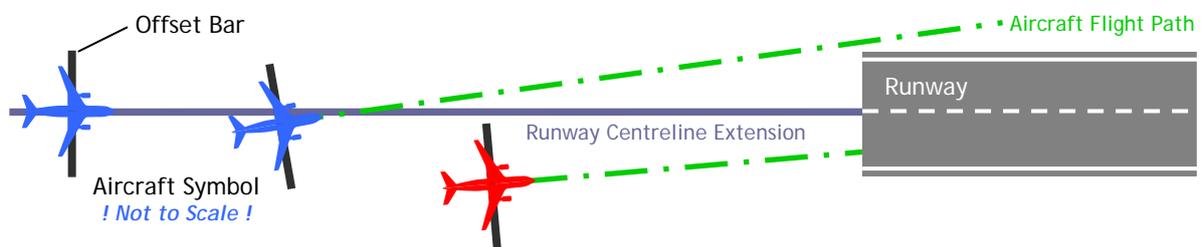
Figure 78: Determination of runway currently being approached

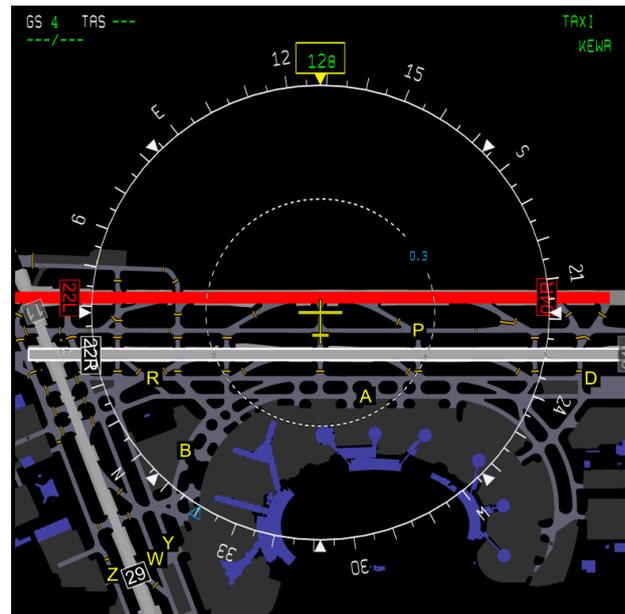
Figure 81: Runway Incursion warning alert (Level 3) visualisation

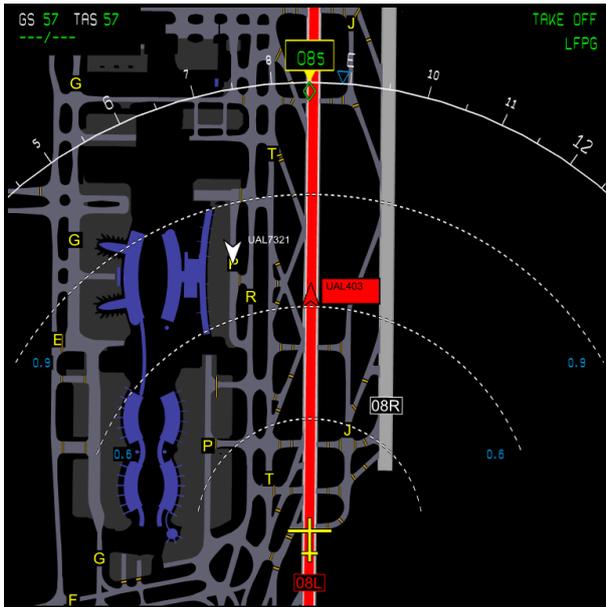
Figure 82: Visualisation of reactive Runway Incursion warning (Level 3 alert)

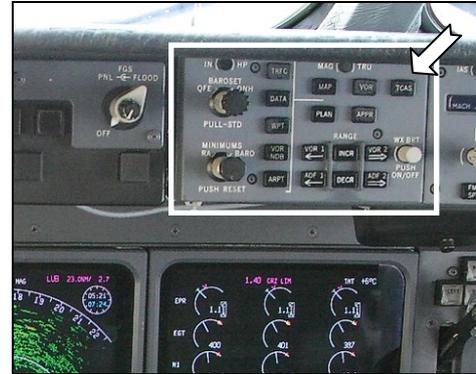
Figure 84: McDonnell-Douglas MD-11 EIS Control Panel (ECP) on Captain's side with selector for dedicated TCAS mode

To avoid this, and to relieve the flight crew of the task of finding an appropriate range/mode combination for conflicting traffic, an automatic or semi-automatic display reconfiguration upon alert could be envisaged. Other aircraft manufacturers have followed this approach. On the McDonnell-Douglas MD-11, for example, a dedicated TCAS mode can be selected on the ND via the EIS Control Panel (ECP), cf. Figure 84. When the corresponding button is depressed, the ND changes to a 10 NM default range, and all other information, such as weather radar, bearing pointers, flight plan etc. is removed [McD90]. In case of a TCAS resolution advisory, this virtually guarantees that the conflicting traffic is in view, and that other information is de-cluttered. In fact, asking a flight crew to push a single button in an alert situation appears as a reasonable compromise between fully automatic and completely manual display reconfiguration, because it keeps the flight crew in the loop.

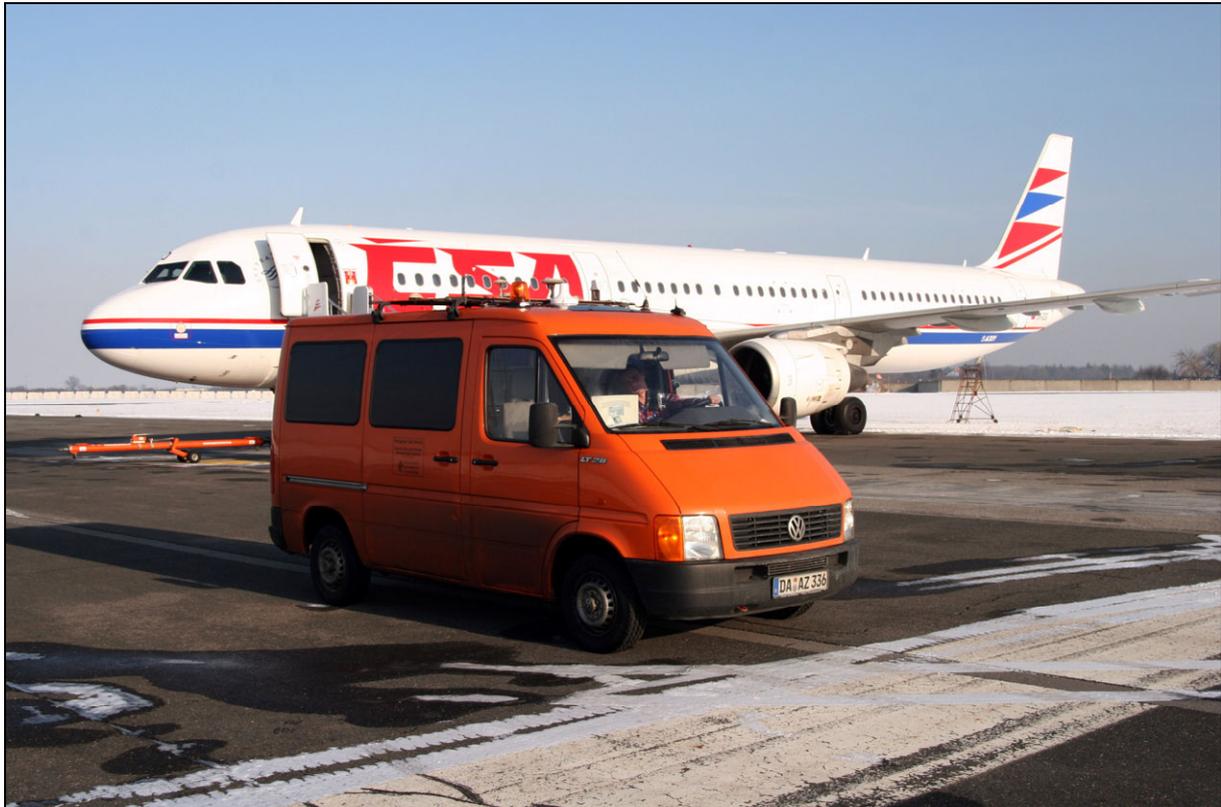
Figure 88: Navigation Test Vehicle during tests on the closed RWY 04/22 at Prague airport (LKPR), February 6th, 2006

TUD's Navigation Test Vehicle, a Volkswagen LT 28 van shown in Figure 88, is operated by the Institute of Flight Systems and Automatic Control and was originally conceived as a mobile test platform for the development and validation of navigation sensors and equipment. It features an array of sensors suited for precise navigation and a measurement data acquisition and logging system. A post-processing software allows to generate highly precise reference trajectories with a CEP₉₅ of 0,44 m based on sensor logs [Sch04].

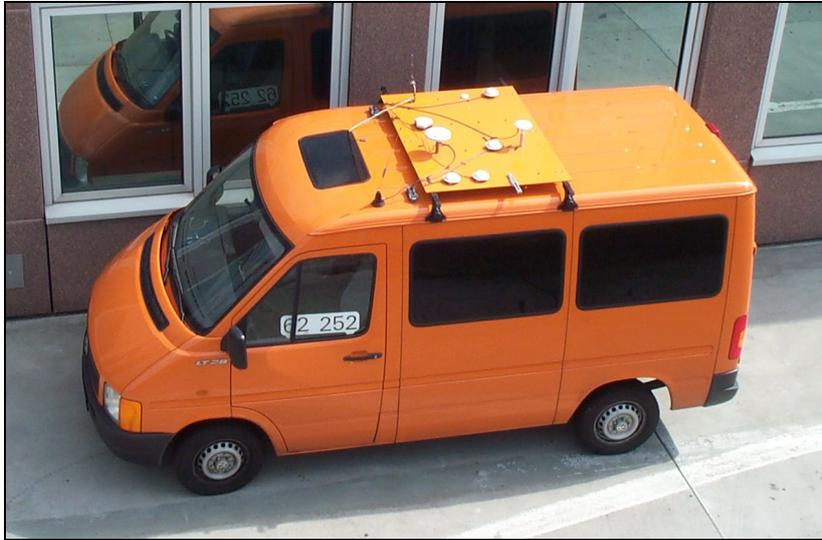
Figure 89: Antenna mounting plate on the roof of the Navigation Test Vehicle

A Honeywell H764 inertial reference system forms the core of the van's precision navigation system, which is supplemented by an array of various GPS receivers ranging from off-the-shelf to high accuracy measurement models (cf. Figure 89). The sensor mounting positions were measured within centimetre accuracy to correct errors caused by different sensor locations. An overview to the sensor equipment is given in Table 16.

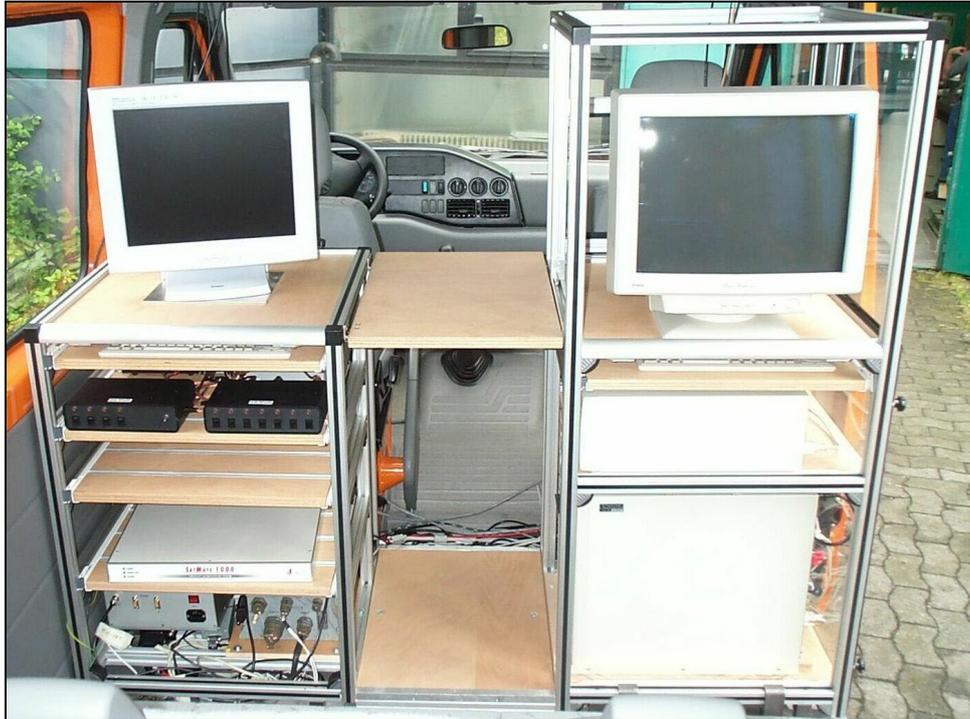
In the back of TUD's Navigation Test Vehicle, one row of seats has been removed to make room for two custom-built, interconnected racks that hold the hardware and computer equipment (Figure 90). Two inverters in the back are used to convert the 12V DC supplied by the vehicle's electric bus to 250V/50 Hz AC required to drive the PC equipment.

Figure 90: Hardware and computer racks in the back of the vehicle

In its standard configuration, the Navigation Test Vehicle is equipped with at least two PCs interconnected by Ethernet. The Navigation PC is responsible for collecting sensor data and the real-time calculation of the GPS/IRS sensor data fusion. It is equipped with both a MIL-1553 and an ARINC 429 card to interface with common aircraft avionics. The other PC is used for multiple purposes, such as data logging, acquiring traffic data and calculating a traffic data fusion or hosting software prototypes of onboard functions such as an airport moving map. Space permitting, further PCs can be added and connected to the vehicle's Ethernet network.

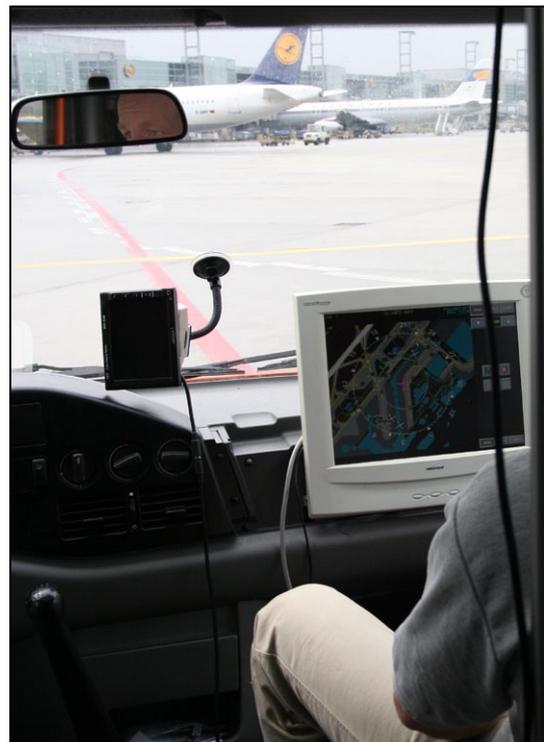
Figure 91: LCD screen installation in front of passenger seat

Although the LCD used is far from the ruggedised, high-contrast AMLCD screens used in aircraft cockpits, the display readability was very good even in back light conditions. Another limitation of the screen used is that its diagonal is a factor of 1.5 larger than the 6" x 8" screens currently used in the Airbus A380.

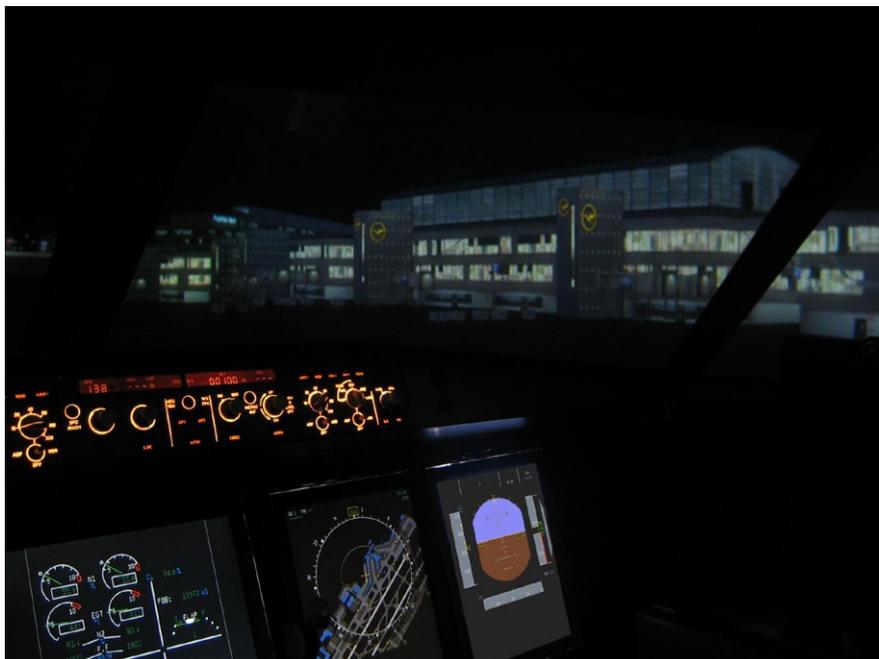
Figure 146: Flight simulator during night taxi scenario at Frankfurt Airport (EDDF)

The cockpit is not an exact reproduction of the flight deck of any specific aircraft, but deliberately kept at the more generic level of a modern 'glass cockpit' with two flight crew members. The inside dimensions of the cockpit correspond to those of a modern widebody aircraft of the Airbus A330/340 family. While the flight simulation employs the flight mechanical model of an Airbus A300 B2, a fly-by-wire flight control system with side sticks was chosen because it represents the state of the art and allows an unobstructed view of the flight guidance displays.

The cockpit features all primary and secondary controls; in some cases actual aircraft parts, such as an original A320 Flight Control Unit (FCU), contribute to enhance the level of immersion and realism. In other cases, as for the MCDU, parts obtained from a commercial supplier of flight simulation equipment have been used, and even some developments of the Institute were installed. As an example, the simulator features active side-sticks, which can also be operated in a standard mode. Flight guidance and system displays are presented on large 15" LCD screens, which can either be arranged in portrait or landscape mode.

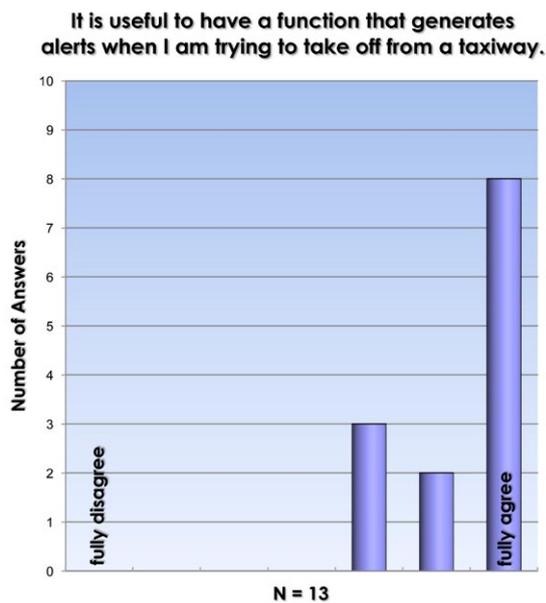
Figure 214: Operational relevance of warning upon taxiway take-off

The results presented in Figure 214 demonstrate that all participants acknowledged the need of a warning protecting flight crews against inadvertent take-off from a taxiway ($M = 5.38$, $SD = 0.87$), as well as the contribution of this alert to flight safety, as shown in Figure 215 ($M = 5.62$). The distribution of results for this latter question exhibits a significant deviation from normality.

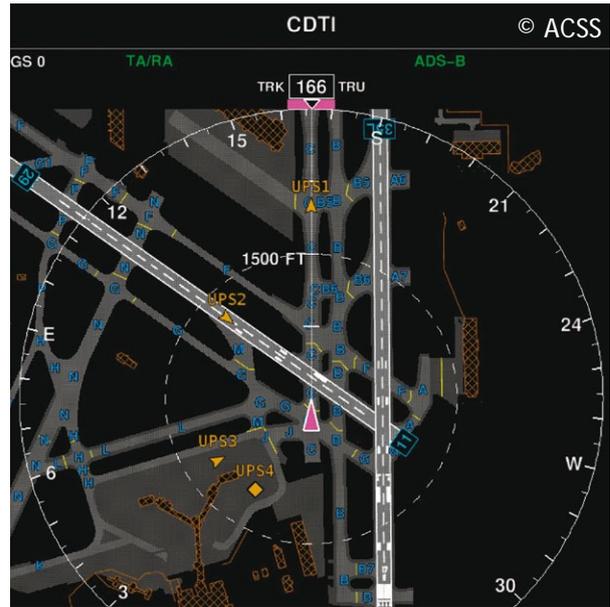
Figure 220: SMAAS Prototype (2007) [Ver07] Figure 221: SafeRoute (2008)

As mentioned already in Section 3.1.3, the Human-Machine Interface (HMI) of SafeRoute has evolved considerably from the initial design presented in Figure 240 to the current product shown in Figure 221. There is a remarkable resemblance between the current SafeRoute HMI and an intermediate version of the SMAAS HMI design that was presented in several publications in 2006 and 2007, cf. [Ver06, Ver06a, Ver07]. Figure 220 shows a SMAAS screenshot taken from a paper presented at the International Symposium on Enhanced Solutions for Aircraft and Vehicle Surveillance (ESAVS 2007) organised by German Institute of Navigation (DGON), cf. [Ver07].

When comparing Figure 220 and Figure 221, the most striking resemblance is the use of the TCAS proximate traffic symbol in conjunction with an identification label for traffic that is apparently (in the case of UPS4 parked at the gate in Figure 221) not supplying a valid heading via ADS-B. Additionally, the following further similarities can be observed:

Furthermore, the runway labels used in Figure 221 are virtually identical to those used by SMAAS, except for the blue colour. None of these features is present in the original SafeRoute design, cf. Figure 240. It is left to the reader to judge whether these similarities are coincidence, or whether the present SafeRoute HMI was partially inspired by SMAAS. In either case, since SafeRoute is a certified product, the resemblance of HMI design features may be taken as further evidence for the validity of the SMAAS design presented in this thesis.

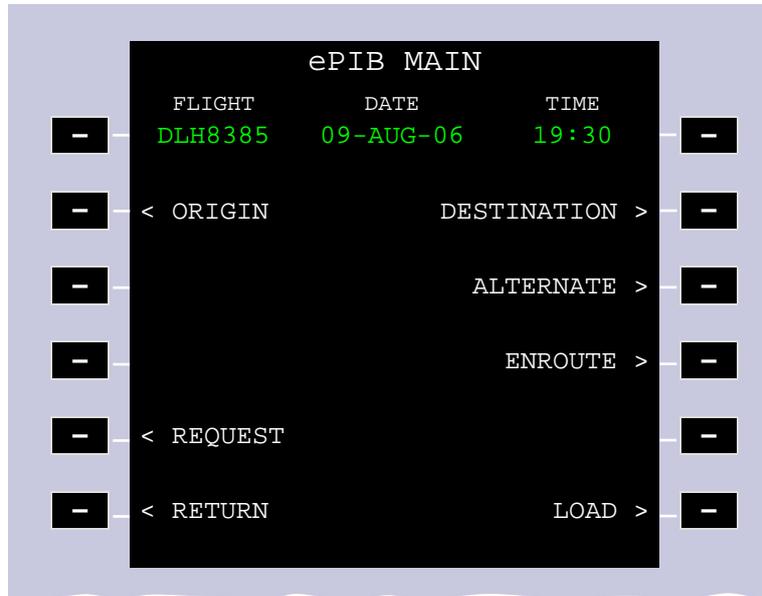
Figure 241: ePIB Main page (MCDU), first design

Figure 241 illustrates the initial design proposal for the ePIB main menu, implemented as a MCDU page. The first line specifies the flight number/flight plan callsign, the ePIB creation date (in most cases this will be identical with the flight date) and the time at which the current bulletin was produced. By pressing the keys adjacent to ORIGIN, DESTINATION, ALTERNATE and ENROUTE, the crew can review the PIB content for the respective airport or flight segment on dedicated pages, with examples given in Figure 244/ Figure 245. The link to the LOAD page may be used to upload a different ePIB, e.g. if AOCC sends an update while still on the ground. By default, any available ePIB is always loaded in the most recent version as soon as the appropriate flight number or callsign has been entered on the INIT page. Touching the key next to REQUEST will open a new menu page on which the crew can request updated NOTAM information from AOCC. Depending on the available means of communication with AOCC, this might be a shortcut to the corresponding ACARS page. In the future, this function could be extended by requests directly to the AIS provider. As usual, the RETURN key will re-call the previous page.

Figure 243 presents a combination of both solutions, which uses the structure of the initial design from Figure 241, but indicates the current airport selections as fixed data below the corresponding menu items to address the issues mentioned above.

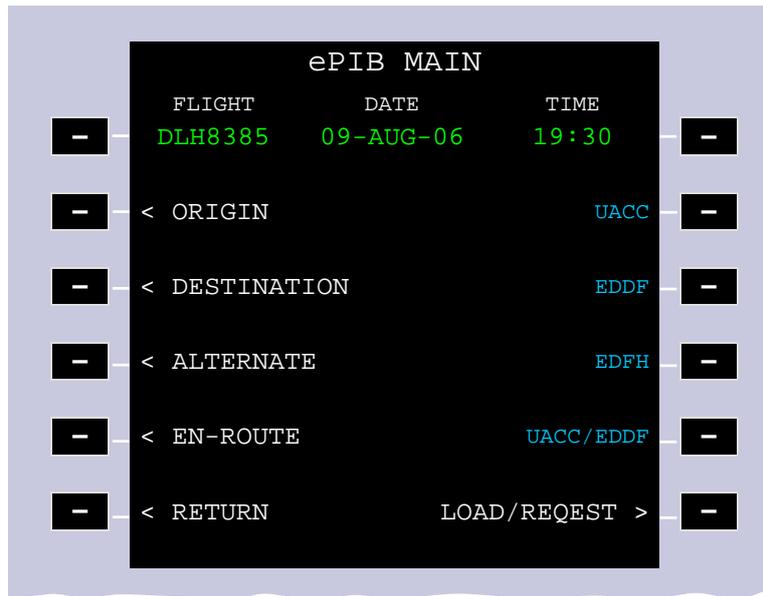
As it should be beneficial from an operational point of view to visualize the selections for origin, destination and alternate airport as a reminder, the menu was rearranged slightly in the first implementation for the FLYSAFE project (in cooperation with NLR) to enable a display of the corresponding ICAO identifiers adjacent to the respective items, as shown in Figure 242. Data are from an actual Lufthansa Cargo flight from Tselinograd/ Aqmola (UACC) in Kazakhstan to Frankfurt/Main (EDDF), with Frankfurt-Hahn (EDFH) set as a destination alternate [DLH06a]. Nevertheless, since it is not desirable that the crew can alter selections already made on the INIT page, this layout should be improved further, all the more as it requires to merge the LOAD/REQUEST item and does not leave any room for potential future extensions.

Figure 242: Alternative ePIB Main page (MCDU)

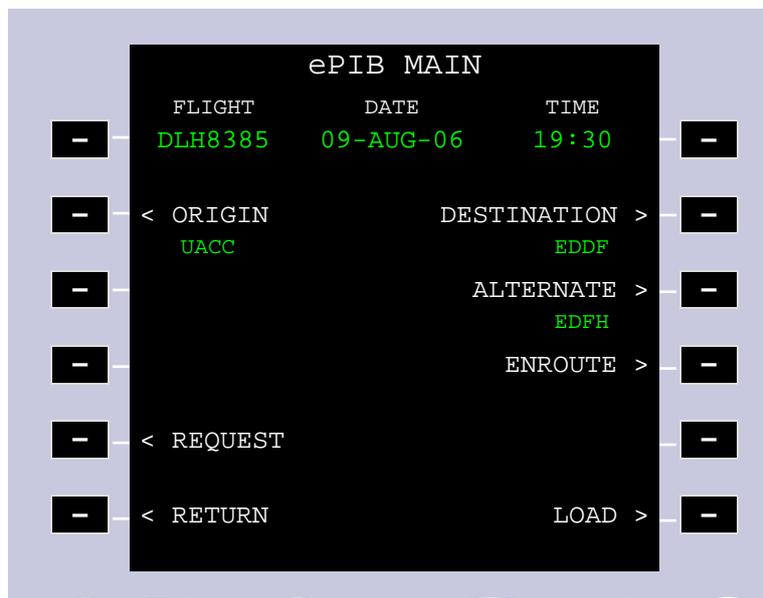
Figure 243: Final ePIB Main page (MCDU)

Any PIB is created for a specific combination of origin and destination. However, since information on several alternate airports is usually contained as well, and thus also in the corresponding ePIB, any change of destination or alternate airport on the INIT page could automatically be reflected on the ePIB Main page as long as the corresponding data are available. If the original ePIB package does not contain information on a selected airport, its ICAO identifier will change to amber. If no flight number has been entered yet, amber dashes in lieu of flight number, date, time and airport identifiers will indicate this.

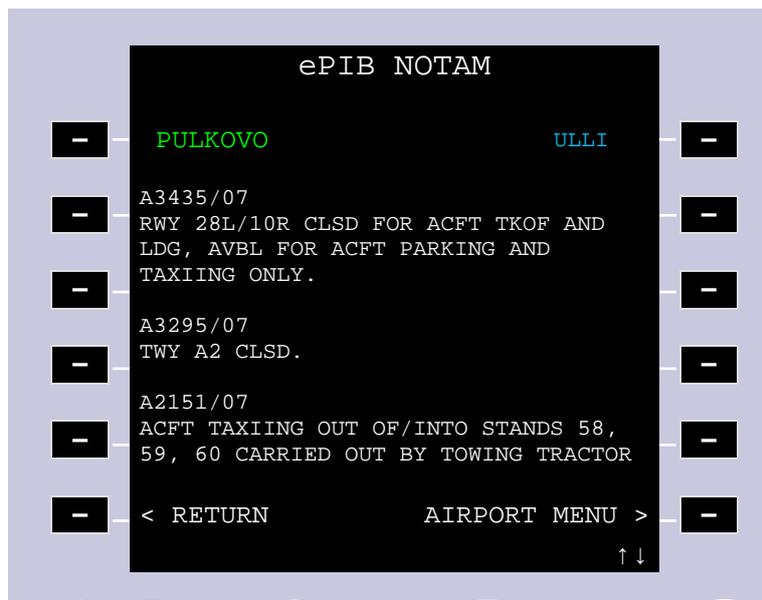
From a usability perspective, flight crews may not want to go back to the INIT page and change the alternate airport just to review NOTAM information for a different alternate airport. This aspect is addressed by the design of the respective ePIB NOTAM page shown in Figure 244, which is called for the respective airport if the line select keys adjacent to ORIGIN, DESTINATION or ALTERNATE in Figure 243 are pressed. Below the airport name and its ICAO identifier, this ePIB NOTAM page lists the NOTAMs contained in the ePIB for this airport. Furthermore, there is a direct link to the Airport Menu (see next section) of the respective airport.

Figure 244: ePIB NOTAM page (MCDU) for airports

By entering a different ICAO identifier using the 1R key, the flight crew can review NOTAM information for any other airport contained in the ePIB, which gives quick access to NOTAM for different (alternate) airports. "NO CURRENT NOTAM" will be displayed in white for any airport covered by the ePIB which does not have any current NOTAMs. By contrast, "NO DATA AVAILABLE" will be indicated in amber for any airport not covered by the ePIB, and likewise, "NOT IN DATABASE", also in amber, will be shown for any airport not covered by the current navigation database of the aircraft.

While the design shown in Figure 244 might give quick access to all NOTAM information, it could become increasingly inefficient with a growing number of applicable NOTAM. Figure 245 shows an alternative approach permitting a more structured review of NOTAM information based on the categories used in conventional PIBs issued by Lufthansa Systems, cf. [DLH06a]. However, this requires an additional pilot selection by pilots before individual NOTAM can be reviewed. However, this solution might be complementary to the solution above, and could e.g. be employed only if the ePIB contains the corresponding structure, which the latter would by default in case there are e.g. 10+ applicable NOTAM for an airport. This might allow the flight crew to access the information of interest in a more structured way.

A potential further drawback of the scrollable plain-text presentation of NOTAM information in Figure 244 is the lack of a possibility to interact with individual NOTAM. However, it is difficult to find a suitable approach to interactivity. With NOTAM serial numbers, which are virtually meaningless to pilots, as sole menu items, the flight crew would successively have to call up several NOTAM to locate the information they are looking for, which does not seem desirable. A way of avoiding this drawback could be listing the first couple of characters below the corresponding identifier for each NOTAM, as shown in Figure 246. In this approach, the full NOTAM text and further details could be accessed through the line-select keys adjacent to the NOTAM number where required. For the NOTAM relating to the runway closures at Frankfurt Airport, A1977/06 and A1970/06, the main information is already visible on this summary page. The colour-coding of the text indicates that these two NOTAM are currently not applicable, since the estimated ETA is outside the time of daily validity, as discussed above.

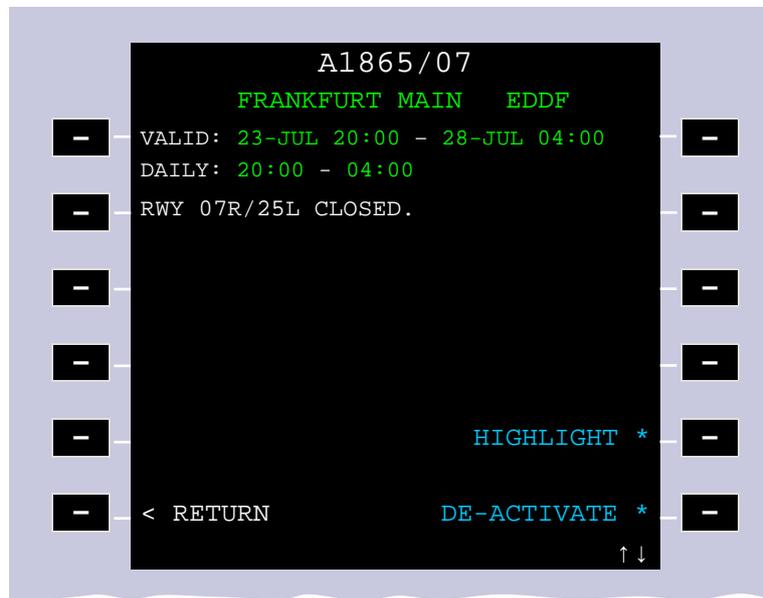
Figure 248: ePIB NOTAM review page with highlight function

Daily limitations of validity should also be indicated for any NOTAM containing a corresponding restriction, as illustrated by Figure 248. For NOTAM referring to an AMDB or navigation database element or any other item with a defined geographical location, such as a temporary obstacle, the corresponding features could be highlighted on the ND if the “HIGHLIGHT” function is activated. The operational value of this highlighting feature will, however, have to be evaluated by further studies.

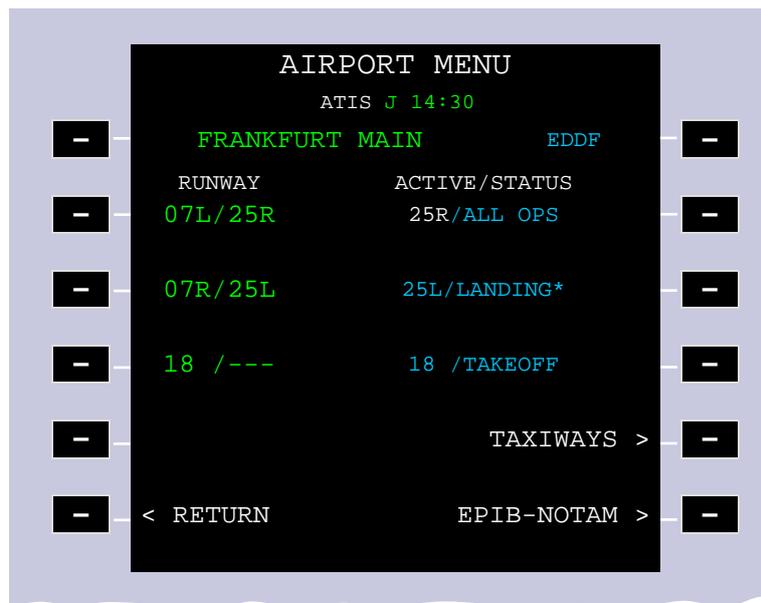
Figure 249: Airport Menu, the main SMAAS MCDU page

The proposed MCDU Airport Menu (Figure 249) provides a synoptic overview of the runways available at a certain airport and their status. This enables the flight crew to review, complete and amend ePIB and D-ATIS information regarding the operational status of the runways for any given airport.

25L in Figure 249. Detailed runway information, with a possibility to review and manually adapt restriction information, could then be accessed by pressing the line-select keys on the left adjacent to the corresponding runway designators.

Future studies will have to reveal whether a dedicated page for the review and potential amendment of taxiway closures and limitations, as indicated by the caption TAXIWAYS (5R) in Figure 249, is required or desirable. It is likely, though, that a synoptic overview will not be necessary, since taxiway closures and restrictions are neither as time- nor safety critical as those of runways. At any rate, the absence of the TAXIWAY menu item will provide more room to review runway information for complex airports.
