Autonomous and Air-Ground Cooperative Onboard Systems for Surface Movement Incident Prevention

Dissertation

Dipl.-Phys. Christoph Vernaleken

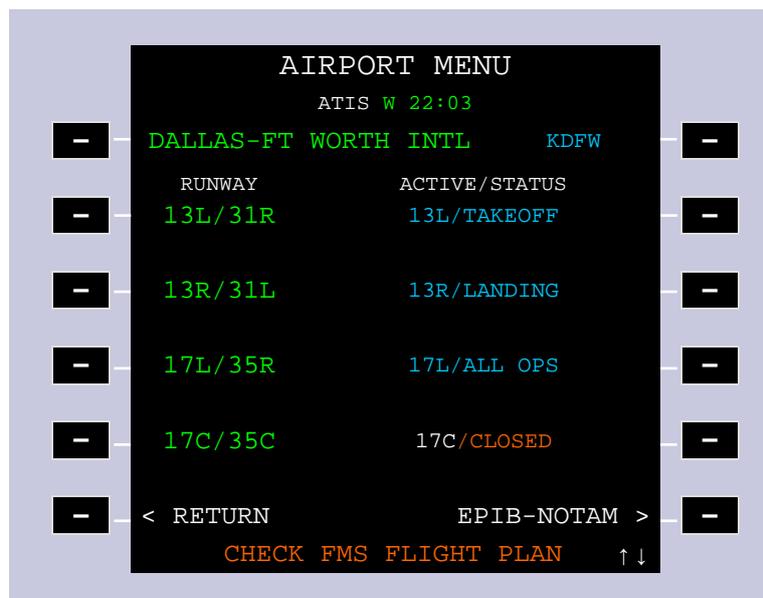
Figure 250: Airport Menu for Dallas-Fort Worth International (KDFW), Part A

Figure 250 and Figure 251 illustrate the behaviour of the Airport Menu for airports with more than four runways, such as Dallas-Fort Worth International Airport (KDFW), which has seven runways. In this special case, the crew has to use the vertical slew keys (↑ and ↓, cf. Figure 59) to scroll through all the runway information available. At the same time, this example is used to demonstrate further envisaged features of the Airport Menu. In Figure 250, the crew has selected RWY 17C as take-off or landing runway in the FMS flight plan. However, since the runway is closed according to ePIB information, the status is displayed in amber instead of blue. Additionally, a message “CHECK FMS FLIGHT PLAN” in the scratchpad advises pilots of this inconsistency, which might result in a dangerous situation if not resolved. As Figure 251 indicates, the message is shown irrespective of whether the corresponding runway is in view on the screen or not. In this example, RWY 17R/35L is neither active nor closed, which is indicated by the dashes and the “NOT ACTIVE”. Technically, the crew could request this runway for take-off or landing, provided there are significant operational reasons [ICA01a]. By contrast, RWY 18R/36L is closed and may only be used as a taxiway, and depending on the precise nature of the closure, it may not be possible for the airport authority to make this runway available on flight crew request, however valid the operational reason might be.

Since a possibility to indicate both the runway-in-use (if applicable) and the general runway status is required, the runways available at the corresponding airport are displayed adjacent to the left hand side LSKs 2L to 4L. Like for any other fix information that may not be modified, a green font colour is used. As shown in the figure, runway identifiers are presented with the lower magnetic runway heading first, and listed by increasing runway heading. For parallel runways, the sequence is Left, Centre, Right. Runway status information is partially obtained from the ePIB, partially from D-ATIS, which is used to retrieve active runway information. To indicate on which ATIS transmission the information presented is based, ATIS code letter and the associated release time are indicated. The FMS-selected runway will always be indicated in white, irrespective of whether active runway information is available. If the status of the FMS-selected runway is not compatible with the desired type of operation, it is presented in amber, as shown in Figure 250.

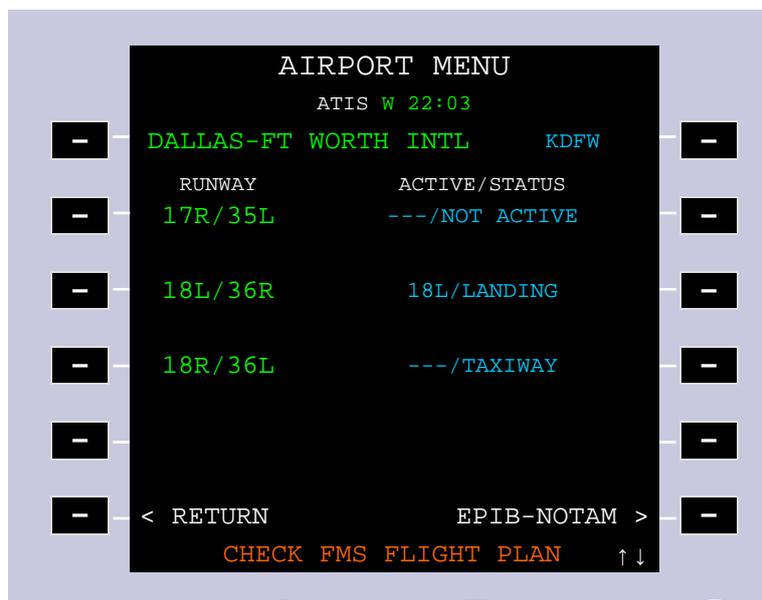
Figure 251: Airport Menu for Dallas-Fort Worth International (KDFW), Part B

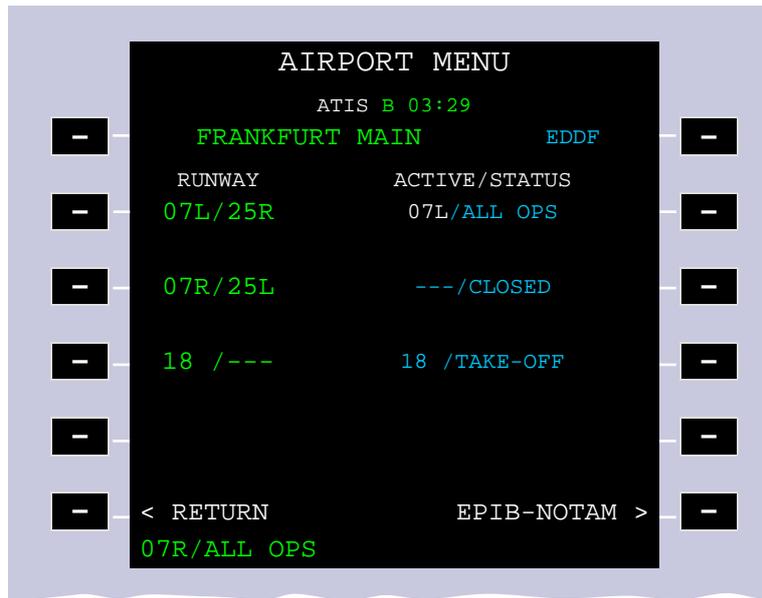
Figure 252 once more uses the example of Frankfurt/Main Airport (EDDF). It is assumed that the ePIB for the flight contains the NOTAM A1970/06 already shown in Figure 246, which effects a daily closure of RWY 07R/25L between 20:30h – 04:00h. Consider the following scenario: A cargo flight taxiing out for departure on taxiway S from the south apron at 03:45h learns from ATC that the runway is already open again, and might elect to use RWY 07R instead of the planned RWY 07L because of the shorter taxi route. In this case, the existing runway status information must be amended. One way of achieving this would be to search and deactivate the corresponding NOTAM as described in the previous section. It appears more convenient, however, to amend runway status information manually.

Figure 252: Airport Menu page with runway closure

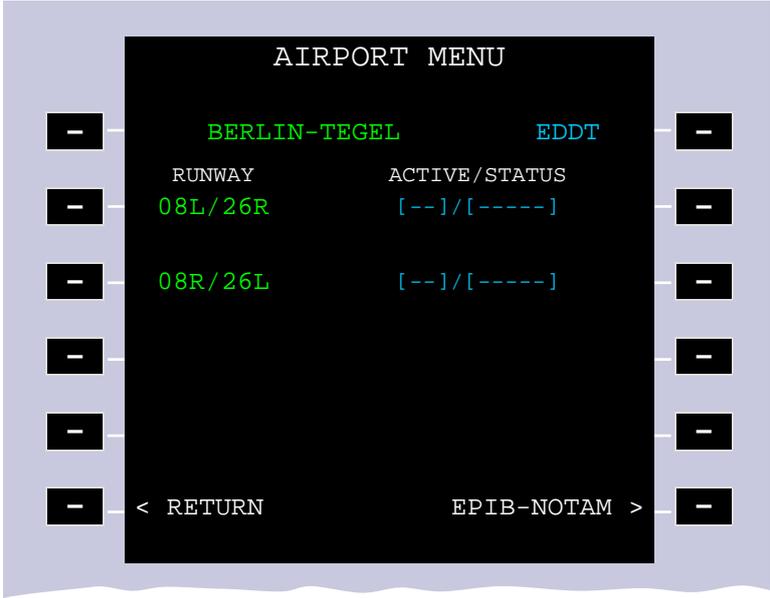
Figure 254 shows the Airport Menu page for a manually selected airport (ICAO identifier in large font) for which no ePIB or D-ATIS information is available. Information on active runways and runway status can be entered manually. Of course, a full entry of all runway-related data by hand is not desirable, since it puts extra workload on the crew in the flight preparation phase.

Figure 254: Airport Menu page for manually selected airport without ePIB and D-ATIS

In principle, the crew could limit manual entries to any runway closures known to them. It should be stressed once more that the basic runway closure display and alerting functions do not require active runway and status information for all runways; one entry for a single closed runway is sufficient.

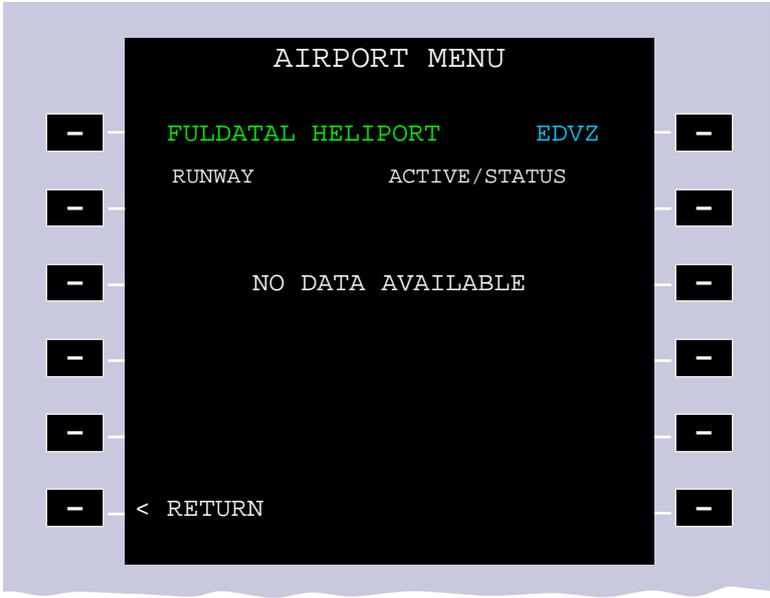
Figure 255 illustrates the behaviour of the Airport Menu page for airports for which, for whatever reason, no runway data is available. In the example below, the airfield in question, Fuldatal Heliport (EDVZ), is obviously used for helicopters only. The same behaviour could be applied to all minor airfields that do not have paved runways. By contrast, for an airport not in the customized navigation database of an aircraft, or an incorrect ICAO identifier, the airport name in the above example will remain blank, with just three amber dashes, and the third line will show "NOT IN DATABASE" in amber.

Figure 255: Airport Menu page in case of airport data unavailability
