## **ENDLESS FIBRE REINFORCED COMPOSITE- METAL-IMPELLER: HIGH SPEED BURST TESTING - DAMAGE AND FAILURE ANALYSIS**

### **SUMMARY**

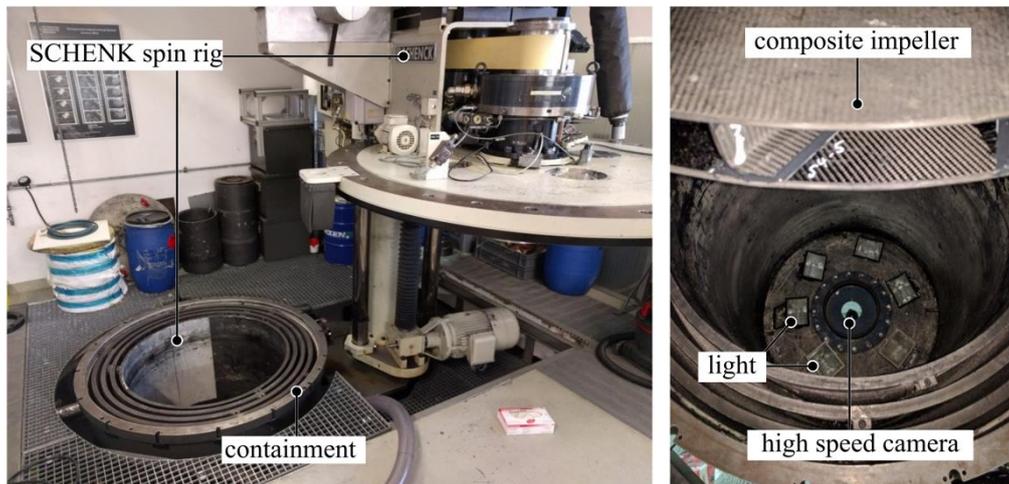
The three manufactured impellers are tested in a Schenk spin rig to evaluate the structural design (acc. Figure 6). Therefore, the fan is mounted at the spin rig gear. High speed cameras are installed at the bottom, observing events during the test.

Figure 6: test set-up in the Schenk spin rig (left) and a mounted composite impeller with the position of the high speed camera (right)
